**REVIEW OF OBSERVED PLUTONIUM-239,240
AND AMERICIUM-241 IN OU2 RUNOFF DURING
THE MAY 16-17, 1995 FLOOD AT THE
ROCKY FLATS ENVIRONMENTAL TECHNOLOGY SITE**

OCTOBER 2, 1995

**U. S. DEPARTMENT OF ENERGY
ROCKY FLATS FIELD OFFICE**

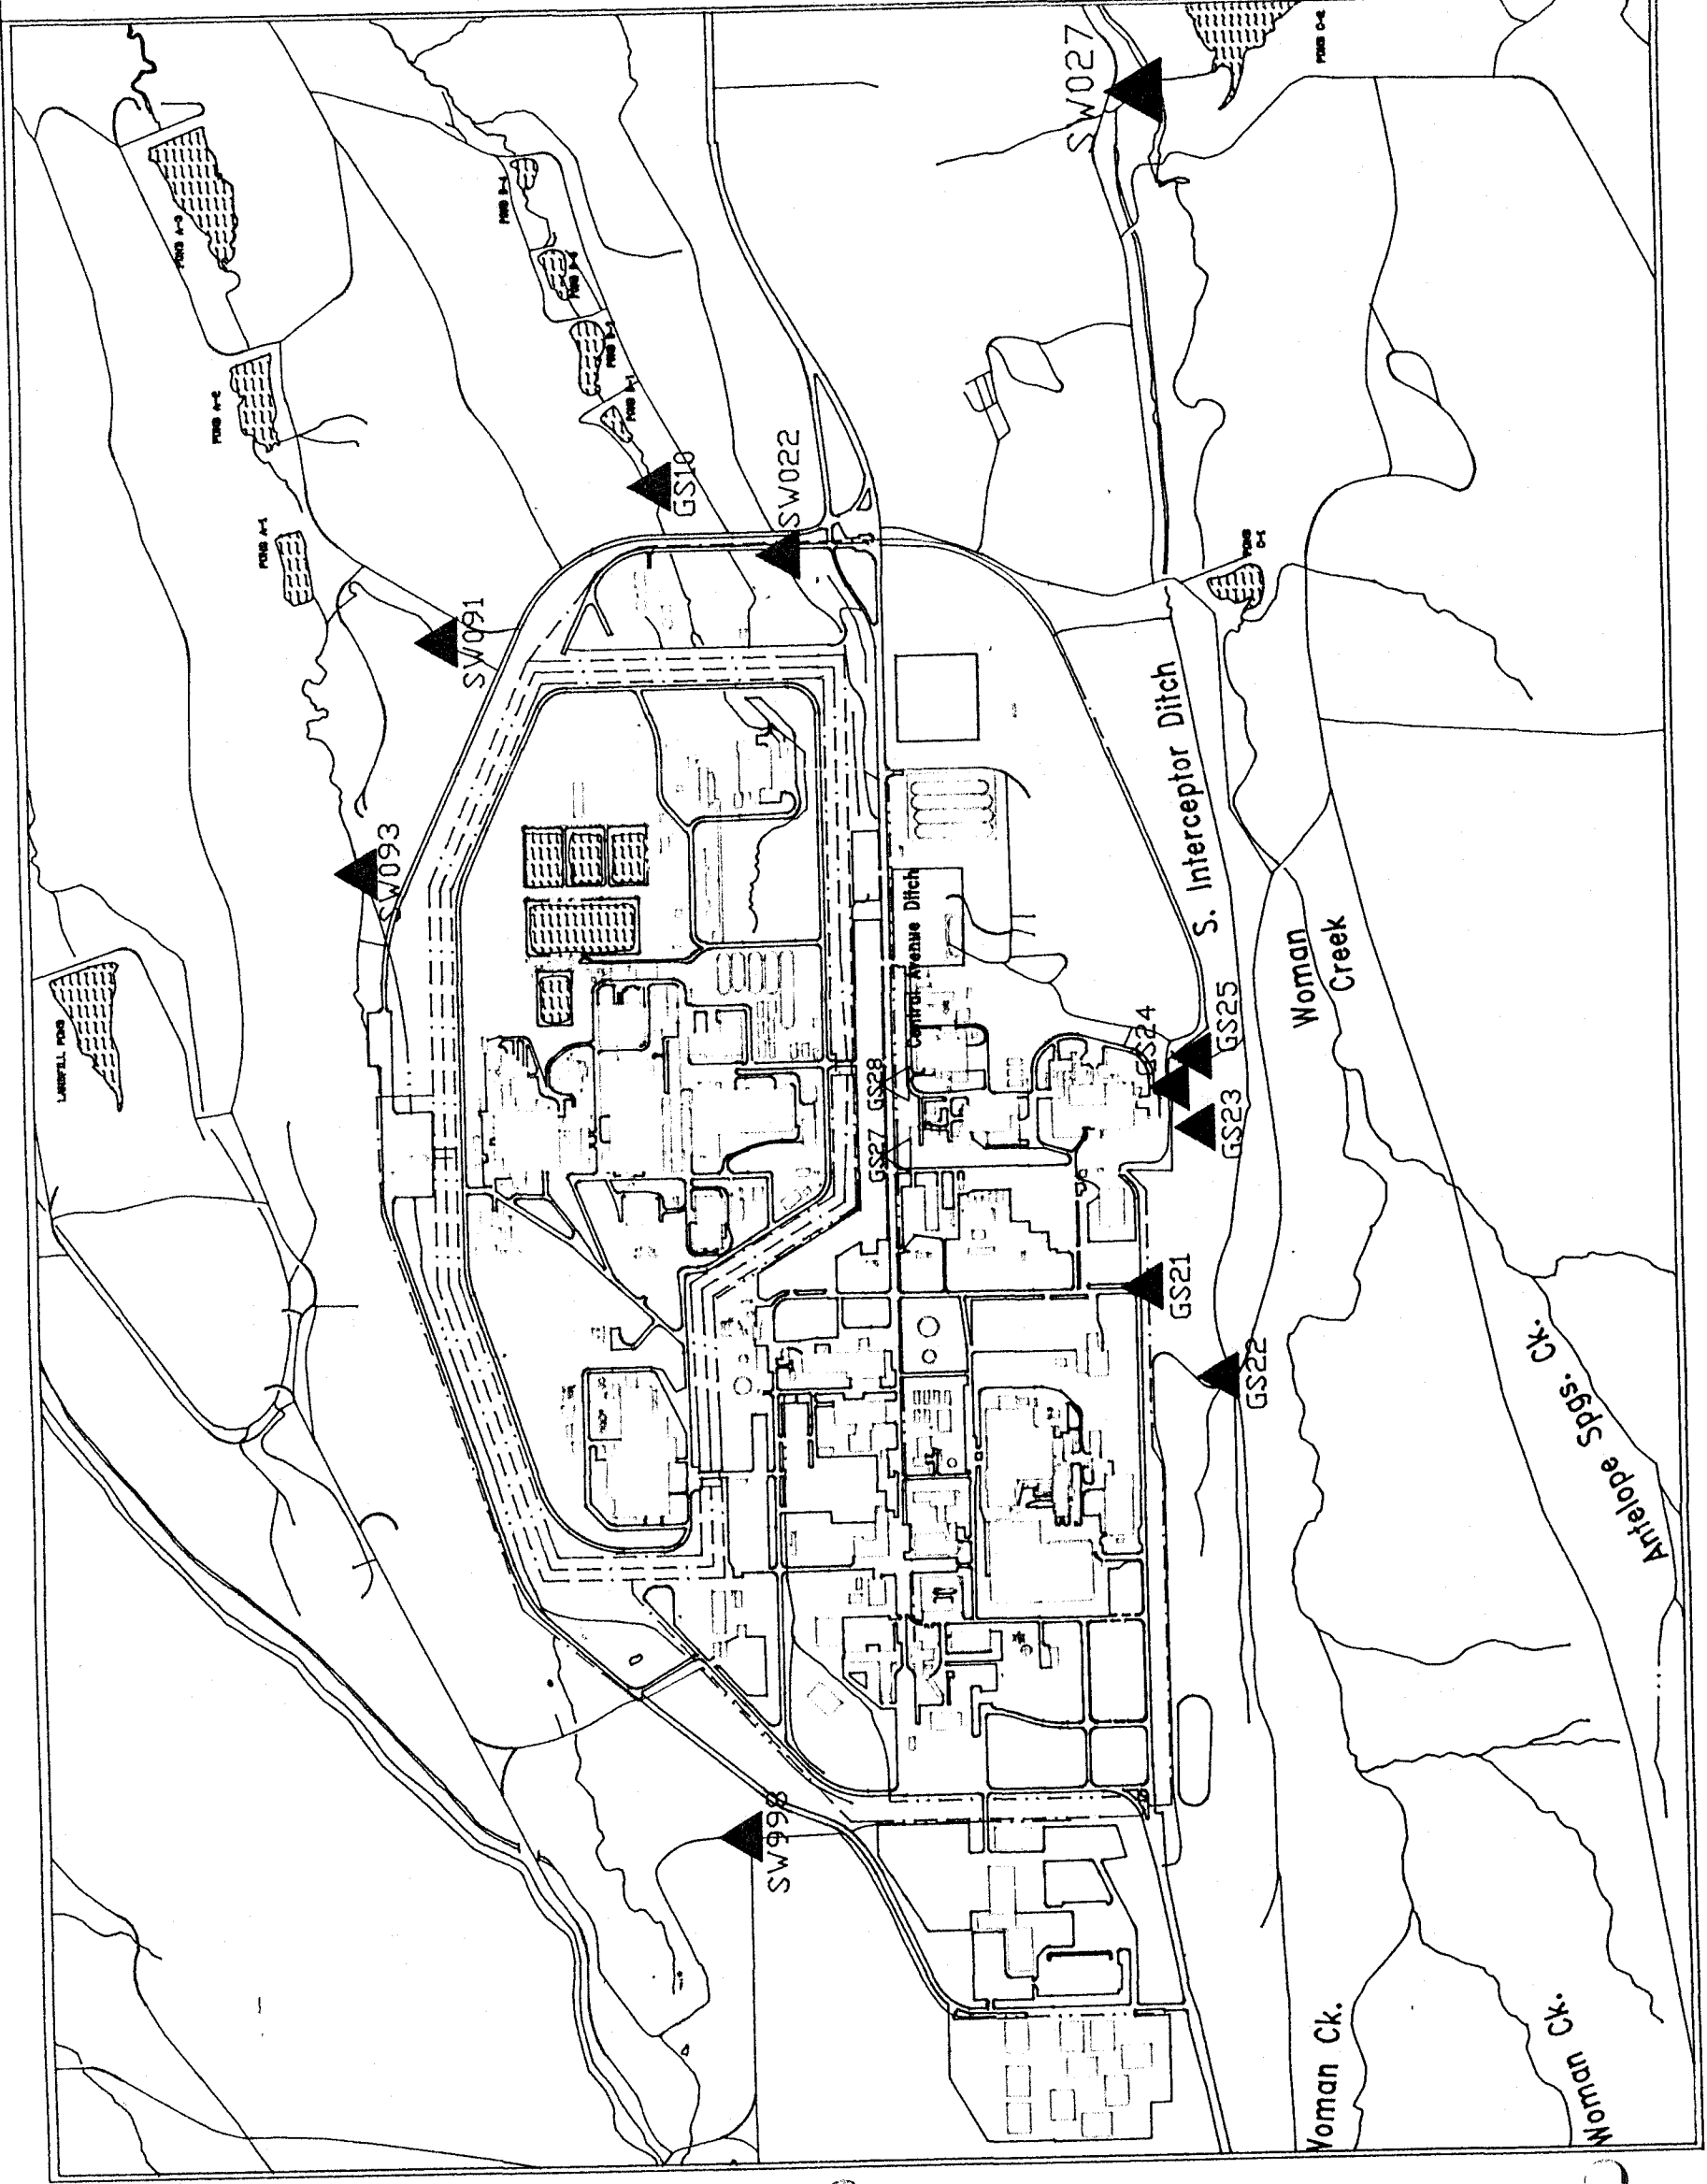
ATTACHMENT 6

Industrial Area IM/IRA
Gaging Station Network
Surface Water
Verification Monitoring
Locations

There are other tributaries to the SID where elevated plutonium-239,240 activities were measured in storm water runoff, although not for the May 17 storm. These locations include gaging stations GS21 and GS24, both located on the 881 Hillside and receiving runoff from waste storage areas (Attachments 5 & 6). Data for several storm water runoff samples from gaging stations GS22 and GS25 indicate that runoff from the Building 460 Area and the east side of Building 881 respectively, do not contain high radionuclide activity; eliminating these drainage areas as significant actinide sources to the SID. A tributary suspected of contributing plutonium-239,240 activity in storm water runoff is a gully which flows intermittently from station SW055 south to the SID (Figure 1). This tributary was not sampled during the May 16-17, 1995 event.
